# Information for the users of the Petzl ZIGZAG

## The facts

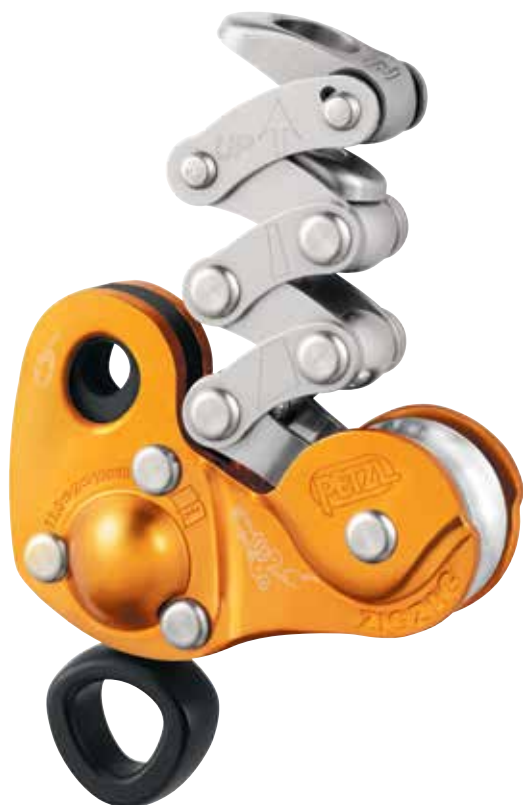
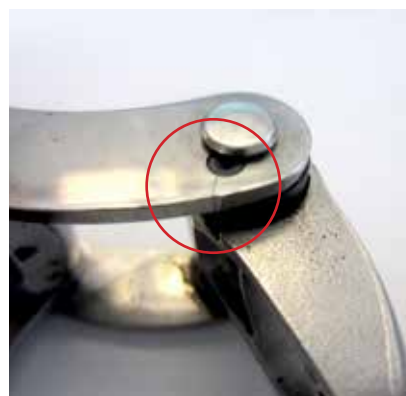
Two different customers have informed us of the presence of a crack on one of the ZIGZAG's steel chain links. Both units have been returned to Petzl for analysis.

A cracked link presents no additional risk to the user. However, the presence of such a crack requires immediate retirement of the ZIGZAG.

- Regularly inspect your ZIGZAG in accordance with the ZIGZAG PPE checking procedure.
- In the unlikely event you find a cracked link, retire your ZIGZAG immediately and contact your local Petzl distributor for a replacement under warranty.
- A cracked link presents no additional immediate risk to the user. However, like for any PPE , the presence of such a crack requires immediate retirement of the ZIGZAG.
- These recommendations therefore apply also to the Petzl ZILLON.

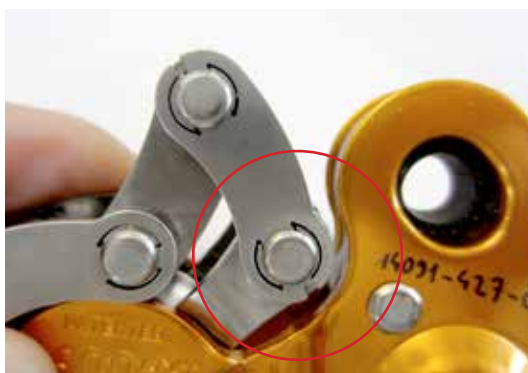
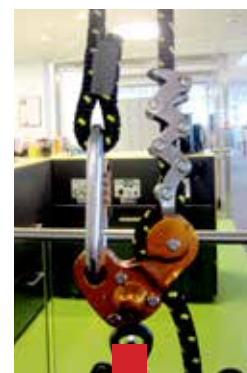
14 kN

we intentionally cut one of the steel links in the ZIGZAG friction chain and performed tensile tests. We cut the link located at the bottom of the chain, as those links are subject to the greatest force.

- The cut link failed at 14 kN, resulting in deformation of the opposite link. However, the chain always remained connected to the body of the ZIGZAG. The same test on an upper link intentionally cut (same damage as one of the two returned cracked ZIGZAG) leads to the same result.

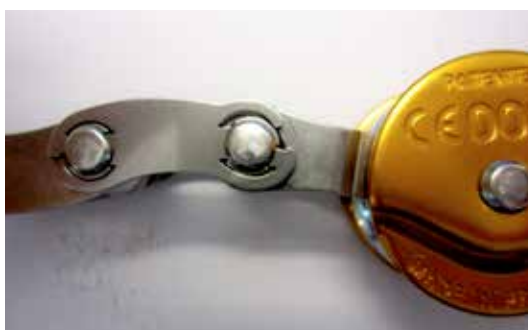
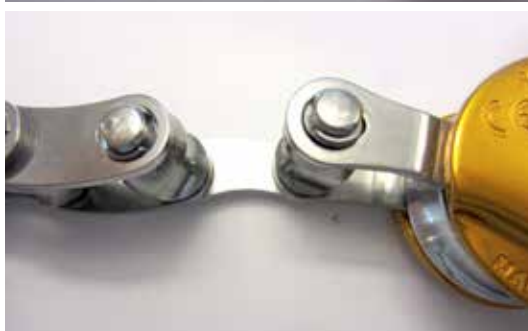
- In a dynamic suspension, the cut link is deformed but not broken (see photos below).
